CIVIL AVIATION AUTHORITY  
AIRWORTHINESS DIVISION

INCIDENT ANALYSIS REPORT

OCCURRENCE NO.	82/01926
CAADRP NO.

Incident Analysis Report No 8	
Title- B747 Engine Failure on Take-off due birdstrikes. Melborne 11.7.82	
Issue 1	Date July 1982

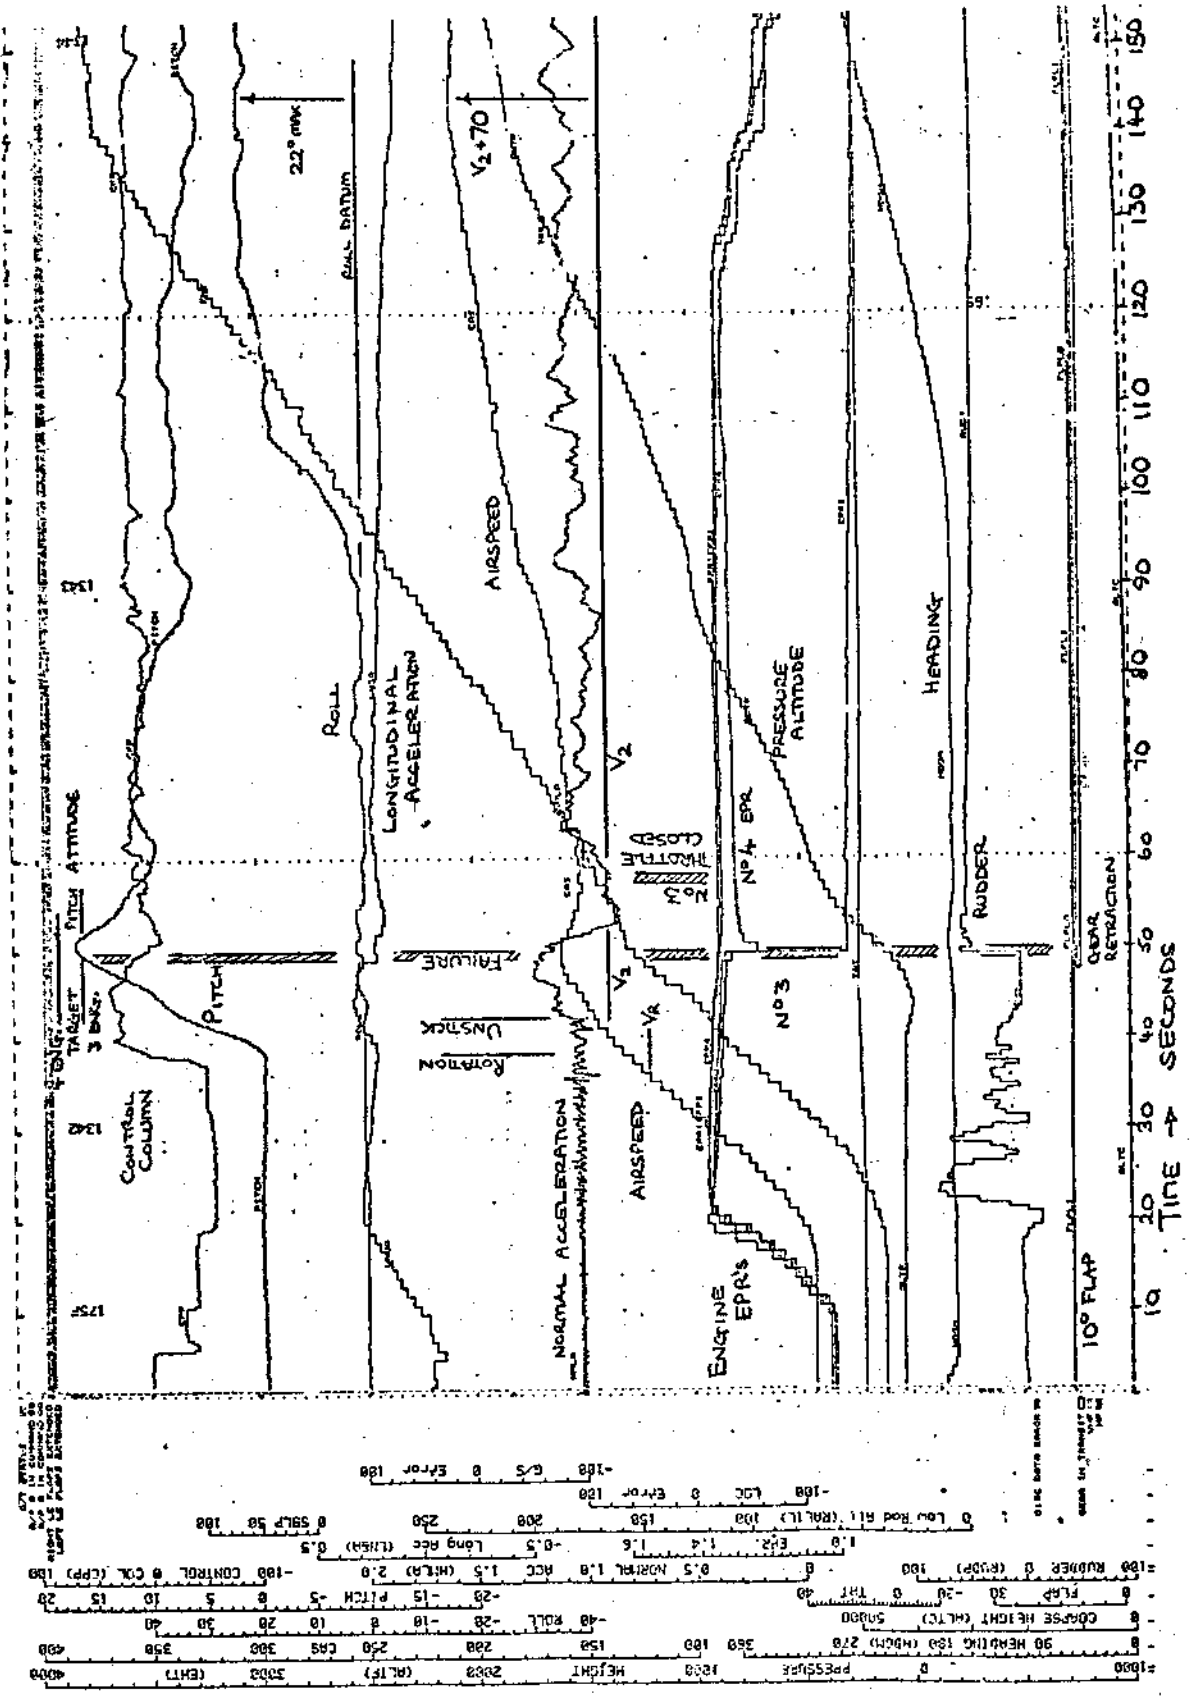
- 6.1 The FDR trace for the incident is shown in Figure 1.
- 6.2 The aircraft was rotated at 127 knots ( $V_r+6$ ) and lifted off at about 145 knots ( $V_2+6$ ), some 33 seconds after the start of roll.

- 6.3 Speed built up to 160 knots ( $V_2+21$  or  $V_4+11$ ) in the next seven seconds, by which time the aircraft was between 54 and 97ft AAL with the gear retracting. The pitch attitude was approaching  $16^\circ$  nose up, the three engine scheduled pitch attitude.

- 6.4 At this point the No 3 EPR's drop from 1.301 to 0.964 within one second and No 4's fall from 1.316 to 1.225. Some 50% of available rudder was instantly applied and the aircraft continued on the runway heading.

- 6.5 The airspeed dropped to a minimum of 150 knots ( $V_2+11$ ) over the next seven seconds, when the crew closed the throttles on No 3. During this time the nose was lowered to  $10^\circ$  and subsequently the speed built up again aided by No 4 engine's increasing thrust, as seen from the change in EPR from 1.225 to 1.290.

- 6.6 The average rate of climb from engine failure to 1500ft was 1000ft per minute, with a maximum and minimum of 1350 and 800 FPM respectively.
- 6.7 At no time did the crew select maximum take-off power on the two undamaged engines, probably due to the very low weight, and during the short circuit flap was kept at  $10^\circ$  (except for the landing). The maximum speed seen was 208 knots and the circuit was flown at 2000ft AAL.
