ENHANCEMENT OF F/RF-4 TRANSPARENCY
SYSTEM BIRD IMPACT RESISTANCE*

Ralph J. Speelman
Manager, Windshield System Development Program
Air Force Wright Aeronautical Laboratories
Flight Dynamics Laboratory

BIRD IMPACT EVALUATION OF THE F/RF-4 TRANSPARENCY SYSTEM

Birdstrikes to the crew enclosures of USAF F/RF-4 aircraft have resulted in major aircraft damages coupled with severe fatal pilot injuries. Analysis of operational bird impact statistical data indicates that the trend of damaging bird impacts of the F-4 is continuing to rise. Impacts to the F-4 transparency system also continue to rise resulting in a continued flight safety risk to the aircraft and the aircrew. The Air Force Wright Aeronautical Laboratories, Improved Windshield Protection Office has initiated a program to develop a transparency system for the F-4 aircraft which has four pound, 500 knot bird impact capability. The first step in this program was to experimentally determine the existing transparency system capability by bird impact testing full scale flight hardware. Eight impact locations on the windshield and forward canopy were tested to failure with four pound birds. Tests on experimental, laminated windshi

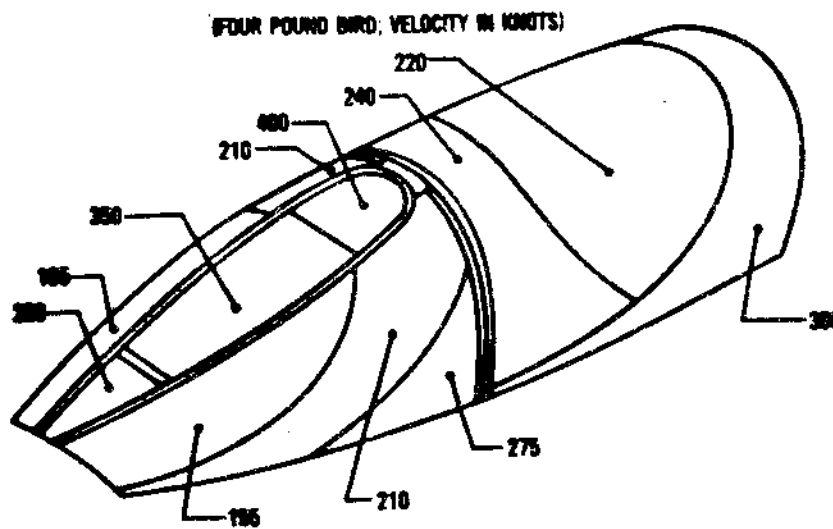
Figure 8. Bird Impact Capability Diagram.

The baseline birdstrike capability for the F/RF-4 transparency system was defined with a total of 25 bird impacts at eight locations on the transparency system. The results of these tests have been summarized in a capability diagram as shown in Figure 8. This diagram presents the four-pound bird impact capability of the existing windshield system with the fuselage oriented at 0° pitch and 0° yaw. This diagram is based on the actual test data with the areas being defined after considering the recorded post-test observations, the high-speed movies, the strain data, the impact angle of incidence, and the proximity to the edge attachment. The values represent an approximate threshold of failure velocity (in knots) for various areas on the windshield and canopy.

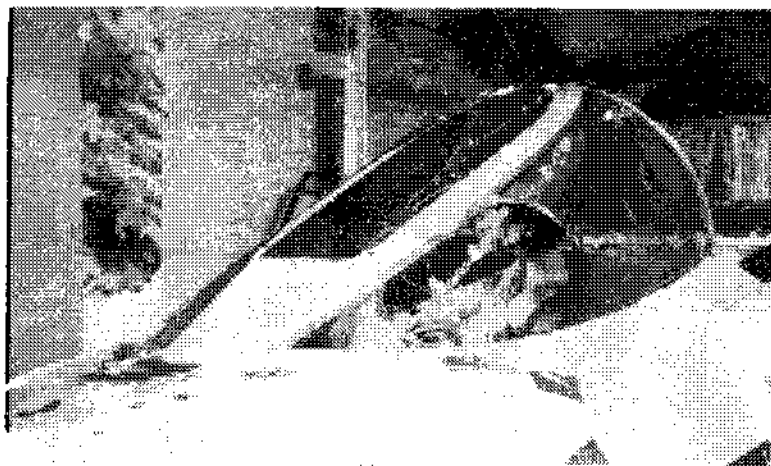
The most critical impact location was on the forward area of the 0.38-inch thick stretched acrylic windshield side panel, impact point "A." The impact angle of incidence was 27 degrees at the target point. Impact point "A" was initially impacted with a four-pound bird at 190 knots which resulted in no damage. A subsequent shot at 200 knots resulted in about half of the four-pound bird penetrating the transparency (see Figure 9). The transparency frame was not damaged.

Figure 9. Post Test Damage, 200 Knot Side Panel Impact.

The data generated from these tests show that the acrylic side panels and forward canopy must be replaced with bird resistant designs which will provide the degree of protection required. Also, the tests indicated that a new or reinforced windshield frame is required.

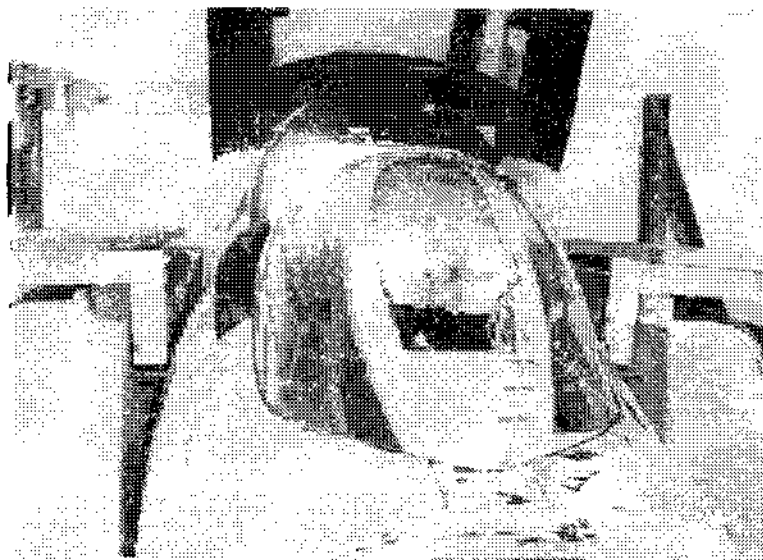
The 1.2-inch-thick laminated glass windshield center panel demonstrated the highest capability of any part of the current transparency system. A four-pound, 300 knot shot on the forward end of the glass center panel (location "D") resulted in a substantial amount of glass spalling off the inside surface; however, no bird penetrated. A shot at 375 knots at location "D" resulted in the failure of the glass center panel. This test was classified a failure because much of the lower half of the transparency spalled into the cockpit, and the pilot would have been facing a considerable wind blast even though no bird actually penetrated (see Figure 10).

Figure 10. 375-Knot Impact Low on Center Panel.

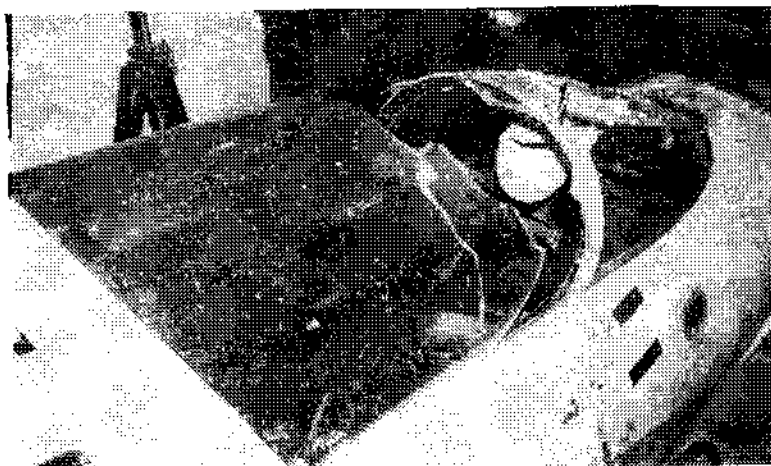
A 450 knot shot at location "C" resulted in a substantial amount of spalled glass. In addition, the center panel was pushed down, buckling the windshield arch supports, and the bird impacted the forward frame of the forward canopy. This failed the canopy frame and transparency, resulting in several large pieces of spalled acrylic as shown in Figure 11. This test was classified a failure because of the potential injury to the pilot.

Figure 11. Post Test Damage, 450-Knot Impact Upper Center Panel.

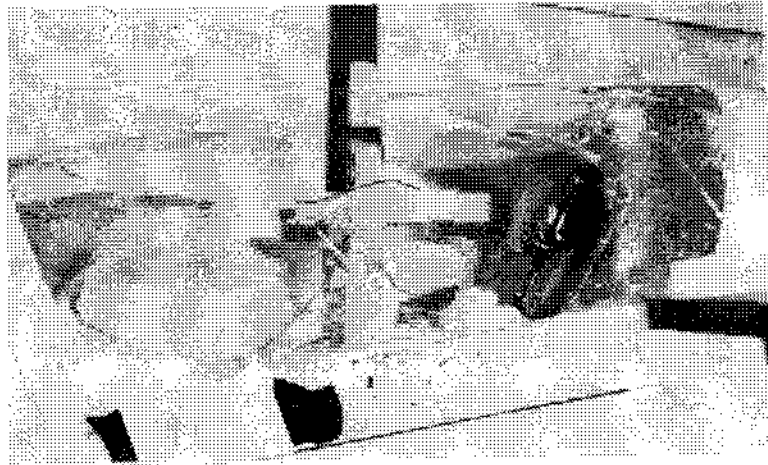
The 0.30-inch thick stretched acrylic canopy was impacted seven times at three locations ("F," "G," and "I"). The demonstrated capabilities were 240 knots at location "F," 220 knots at location "G," and 230 knots at location "I." A 300 knot area was added in the capability diagram to reflect the decreased angle of incidence. No damage to the frame or support structure was found in any of the tests. The transparency, when failed, spalled several large pieces of acrylic (estimated at over 8 sq. in.), in addition to many small pieces. This spalled acrylic could cause serious injury to the pilot. Also, the pilot would be subject to considerable wind blast and buffeting through the large holes left in the transparency (Figure 12).

Figure 12. 270-Knot Impact, Centerline of Forward Canopy.

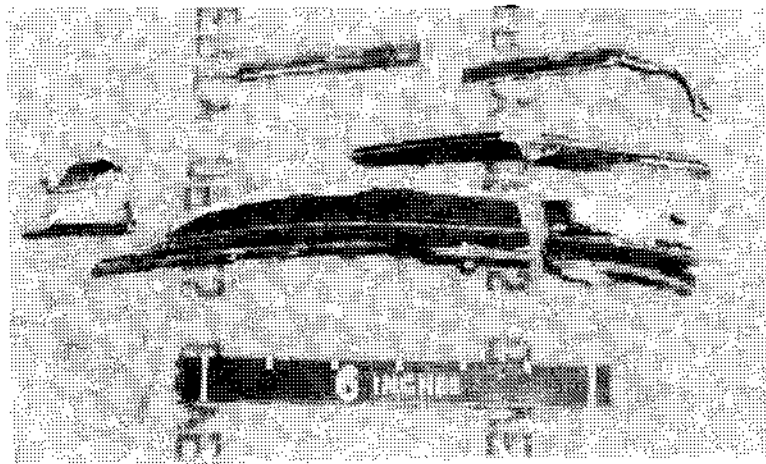
Figure 13. Failed Windshield Arch Fragments.
