ENHANCEMENT OF F/RF-4 TRANSPARENCY
SYSTEM BIRD IMPACT RESISTANCE*

Ralph J. Speelman
Manager, Windshield System Development Program
Air Force Wright Aeronautical Laboratories
Flight Dynamics Laboratory

BIRD IMPACT EVALUATION OF THE F/RF-4 TRANSPARENCY SYSTEM

Birdstrikes to the crew enclosures of USAF F/RF-4 aircraft have resulted in major aircraft damages coupled with severe fatal pilot injuries. Analysis of operational bird impact statistical data indicates that the trend of damaging bird impacts of the F-4 is continuing to rise. Impacts to the F-4 transparency system also continue to rise resulting in a continued flight safety risk to the aircraft and the aircrew. The Air Force Wright Aeronautical Laboratories, Improved Windshield Protection Office has initiated a program to develop a transparency system for the F-4 aircraft which has four pound, 500 knot bird impact capability. The first step in this program was to experimentally determine the existing transparency system capability by bird impact testing full scale flight hardware. Eight impact locations on the windshield and forward canopy were tested to failure with four pound birds. Tests on experimental, laminated windshi

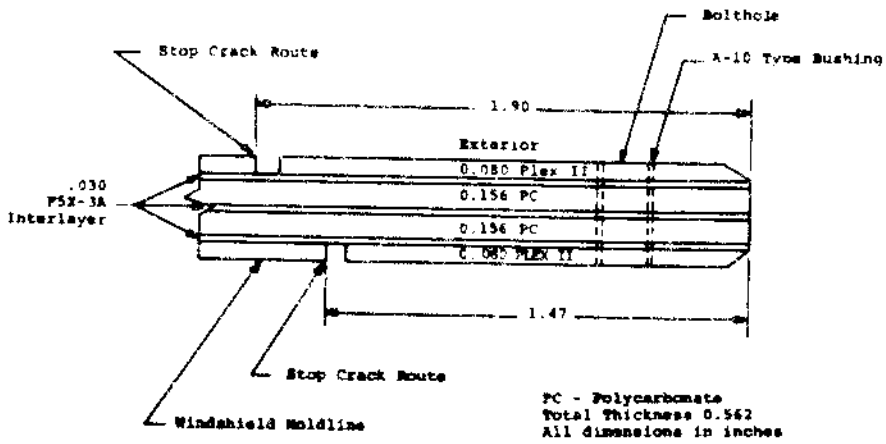
Figure 5. Laminated Side Panel Cross-Section.

The windshield frame capability was determined by utilizing laminated side panels which were designed, developed, built, and donated by Goodyear Aerospace Corporation, Litchfield Park, Arizona. The laminated panel cross-section may be seen in Figure 5. When a transparency failed in a test, it was removed from the frame, the frame was inspected, and if no structural damage had occurred, another transparency was mounted in place.

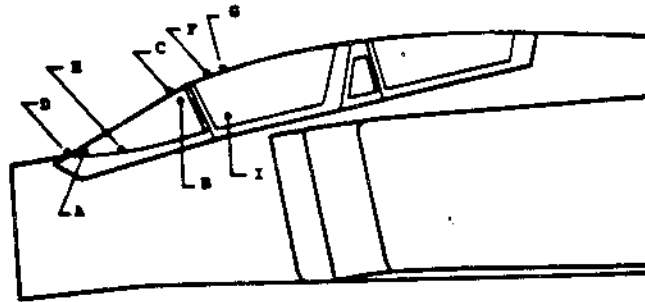
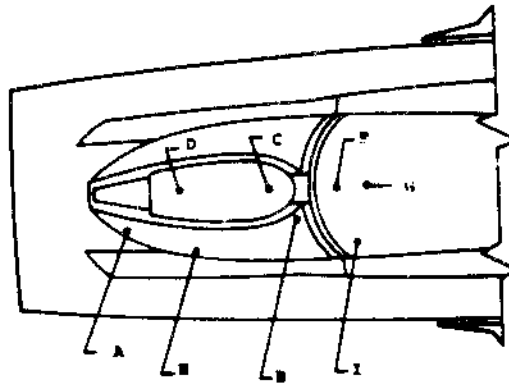
Figure 7. Impact Locations.

The eight impact locations used may be seen in Figure 7. These locations were chosen through the use of an angle of incidence study and represent areas where the maximum energy could be transferred from the traveling bird to the stationary structure. At least two impact locations on each transparency system component were investigated so that a capability map could be developed for the entire system. Impacts at locations "A" through "G" were made with the fuselage section aligned at 0° pitch and 0° yaw relative to the launcher flight path. Impact locations "H" and "I" were chosen to investigate the transparency capability in the sill area. Impacts at these two locations were

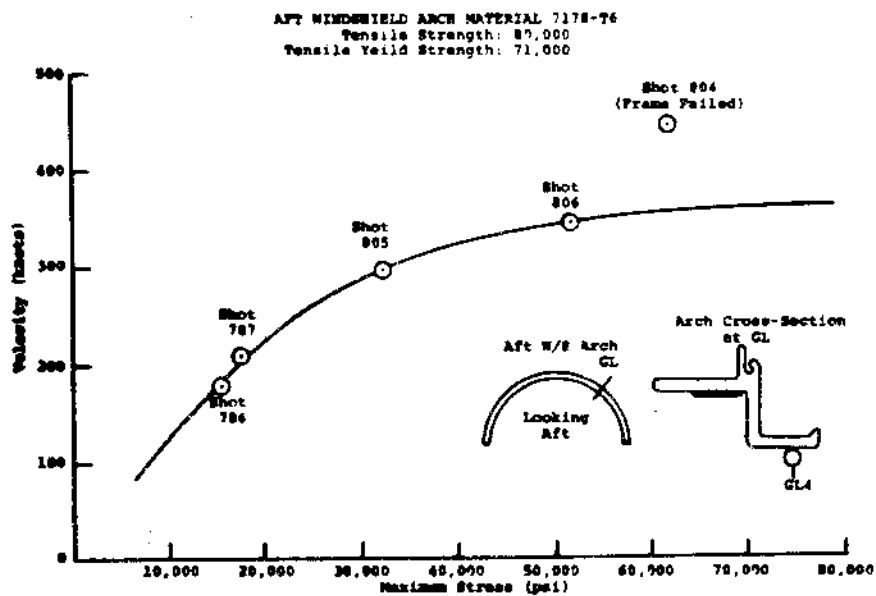
Figure 14. Maximum Stress vs. Velocity Gage GL4 Impact on Location B.
